2019 Construction Season Street Resurfacing Program

Street: Glenwood Road
Starts: Arrowhead Drive
Ends: Cul de sac

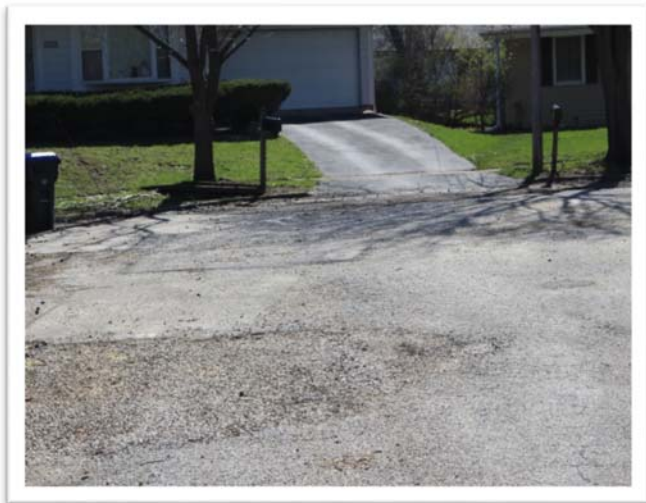
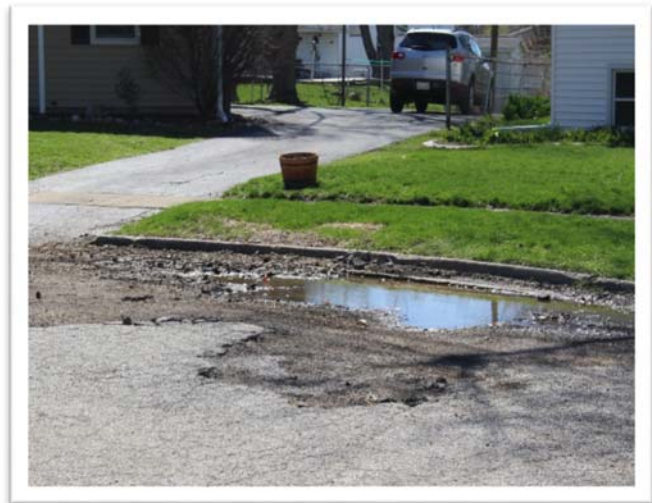
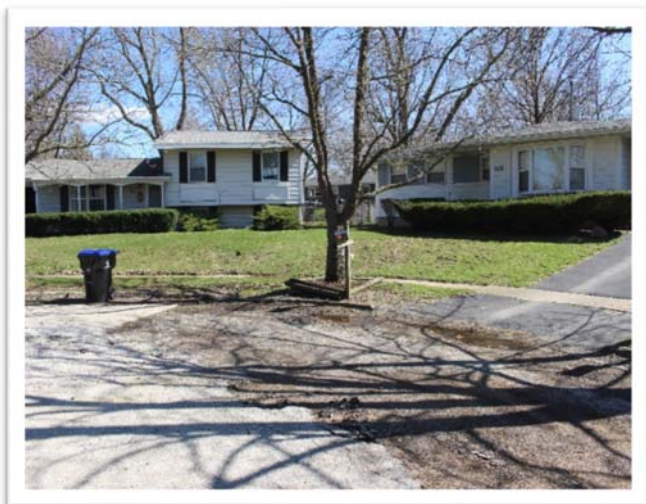
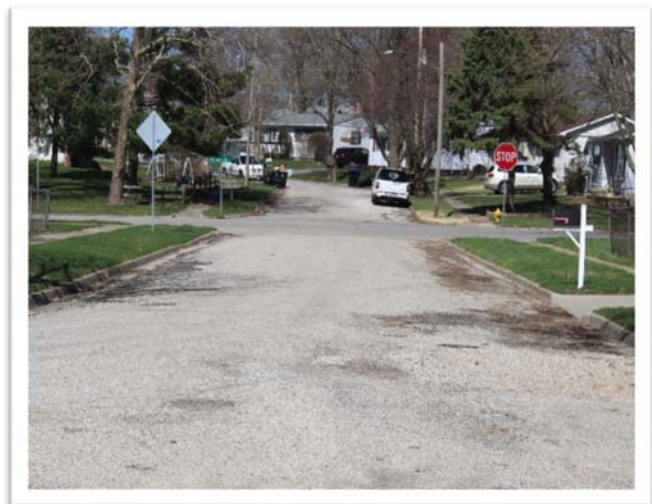
Existing Road Photos:

- Poor pavement condition (Rating: 3 out of 10)
- Poor base leading to failing pavement: reconstructing with deeper removal and replacement to repair the base (Longer term repair)
- Pavement has uneven profile (Lots of dips and bumps): correcting with new paving work to provide smoother ride
- Requested by Streets and Sewers Division due to numerous water main breaks and problems with associated patching. Water main has now been all repaired and/or relocated.
- Last paved 1988 (31 years) according to best available records
